Debris/Ice/TPS Assessment and Integrated Photographic Analysis of Shuttle Mission STS-88

**DEBRIS/ICE/TPS ASSESSMENT
AND
INTEGRATED PHOTOGRAPHIC ANALYSIS
OF
SHUTTLE MISSION STS-88**

4 December 1998

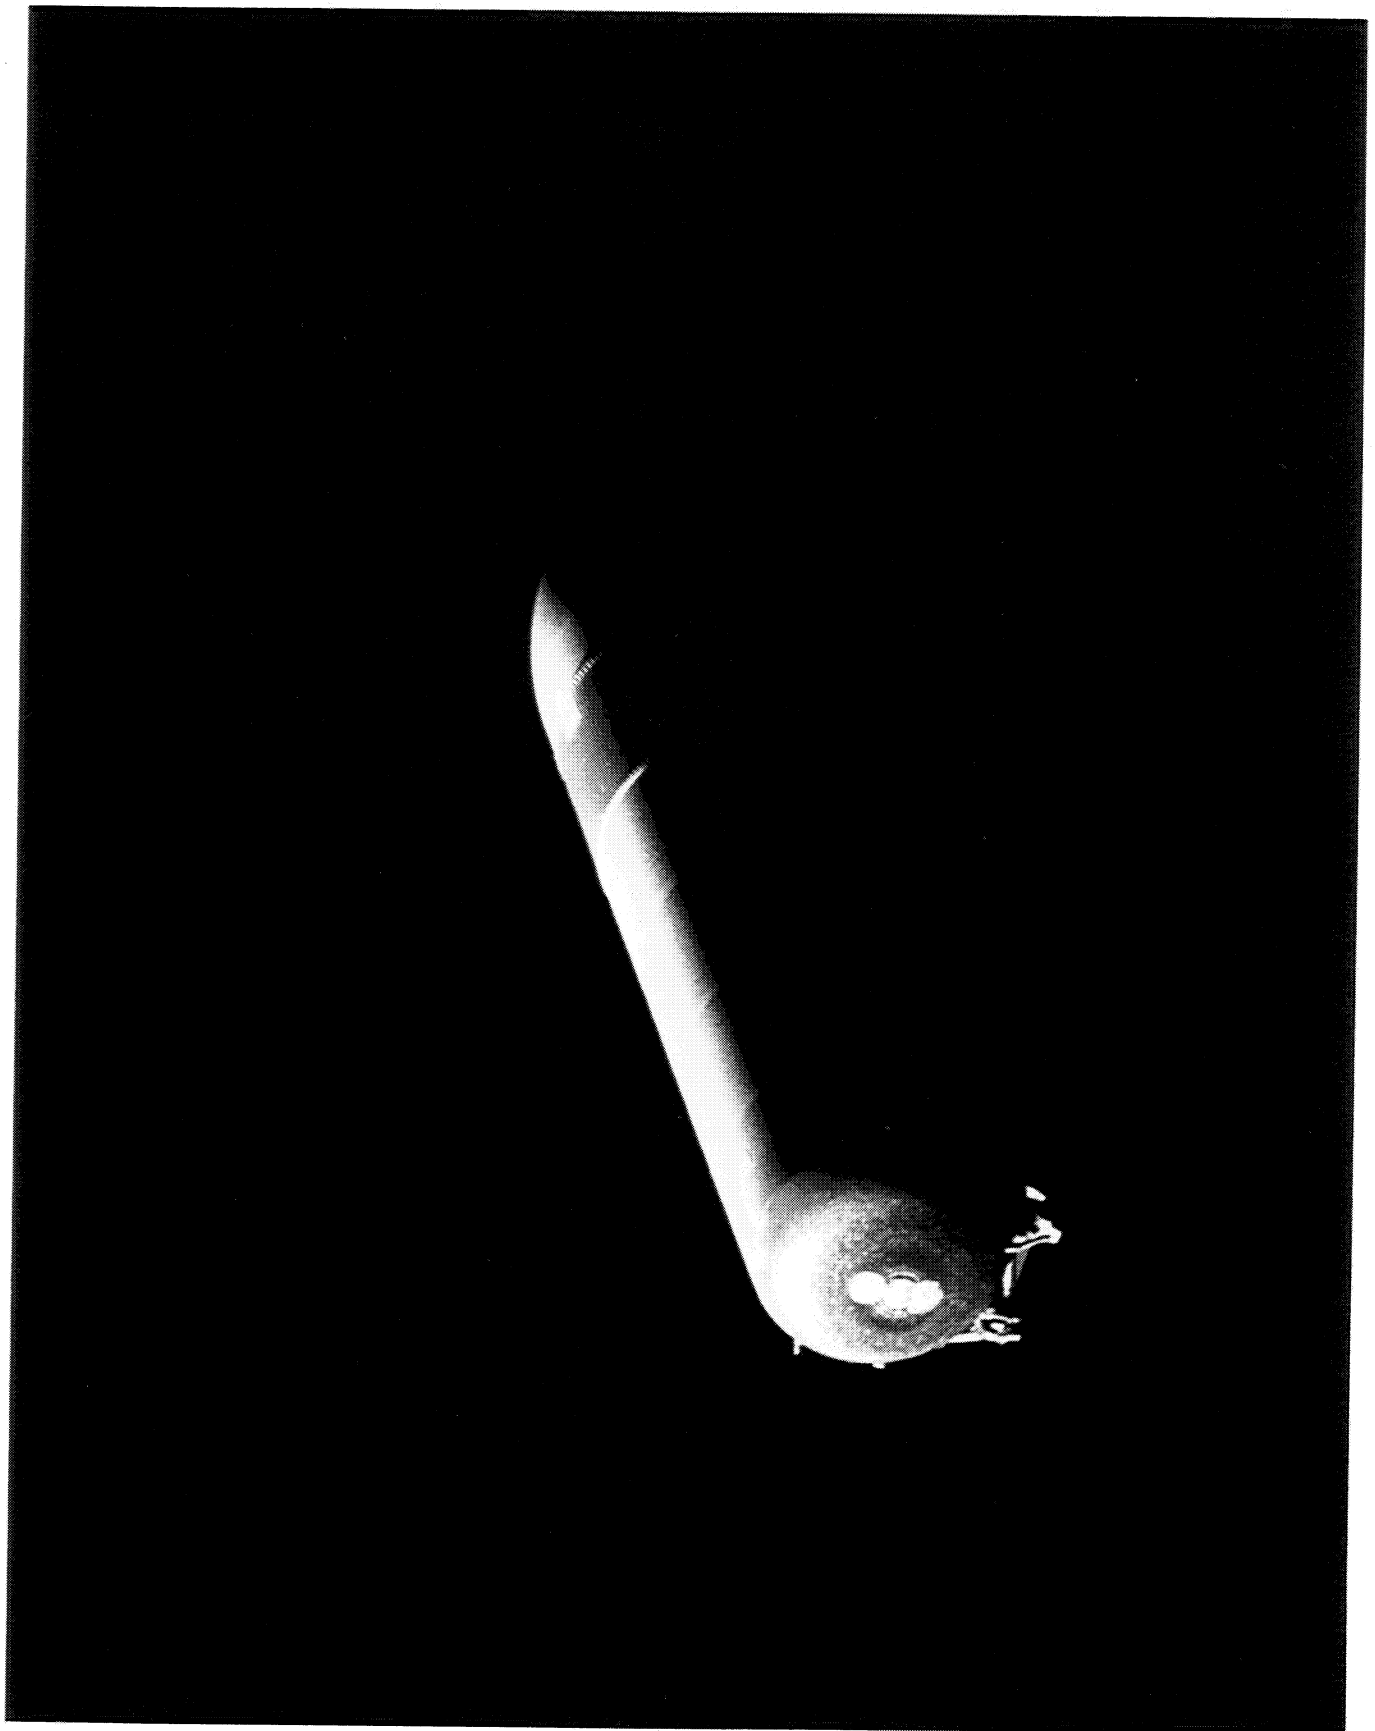
Photo 16: ET Aft dome

For the most part, the still images provided excellent views of the aft dome, aft hard point, LH2 tank acreage, and LO2 tank acreage. There were no anomalies visible in any of these areas.

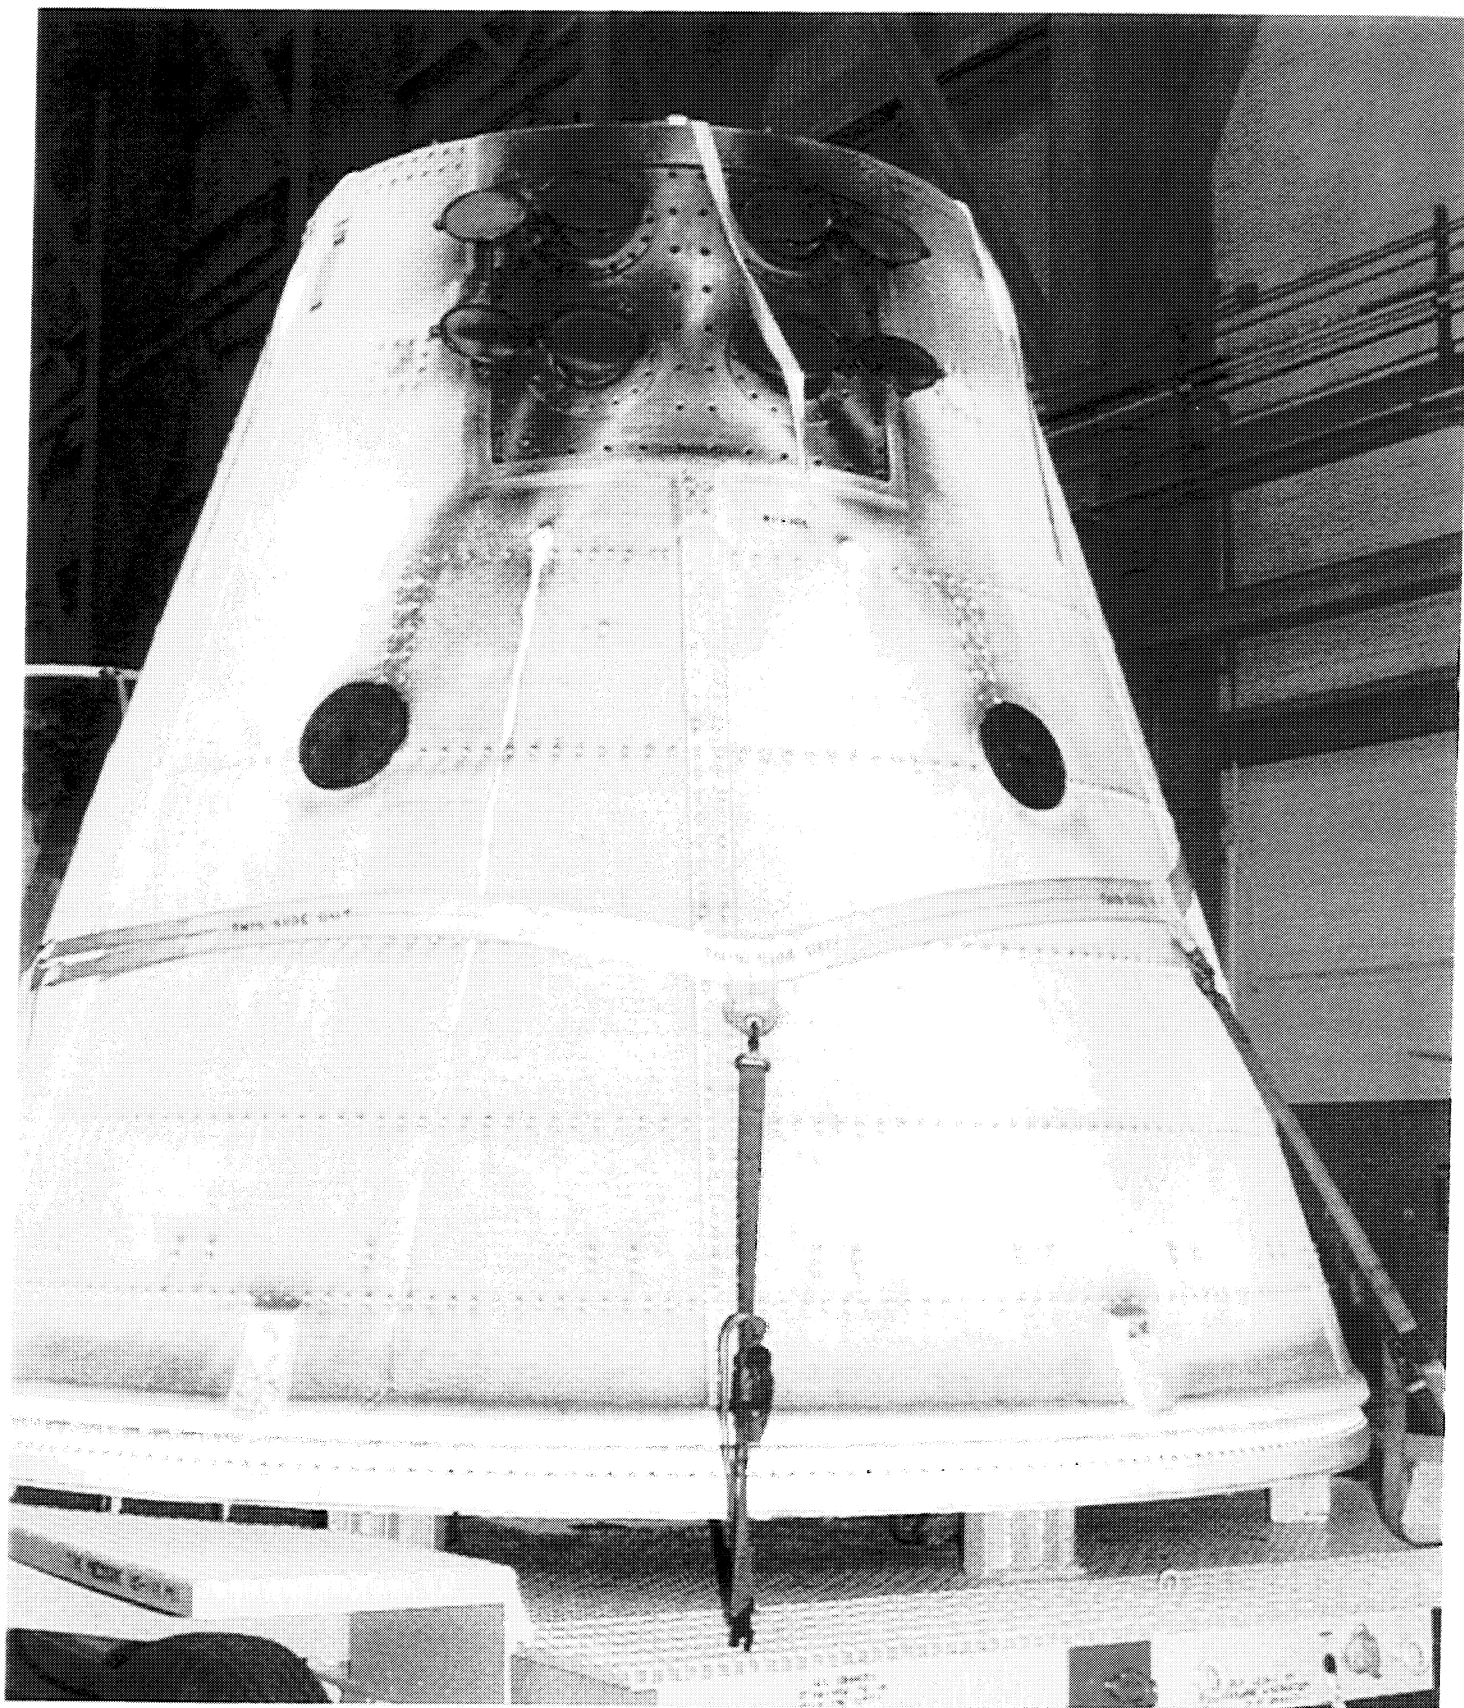
Photo 17: Frustum Post Flight Condition

Both frustums were in excellent condition. No TPS was missing and no debonds/unbonds were detected over fasteners or acreage. All eight BSM aero heat shield covers had locked in the fully opened position.

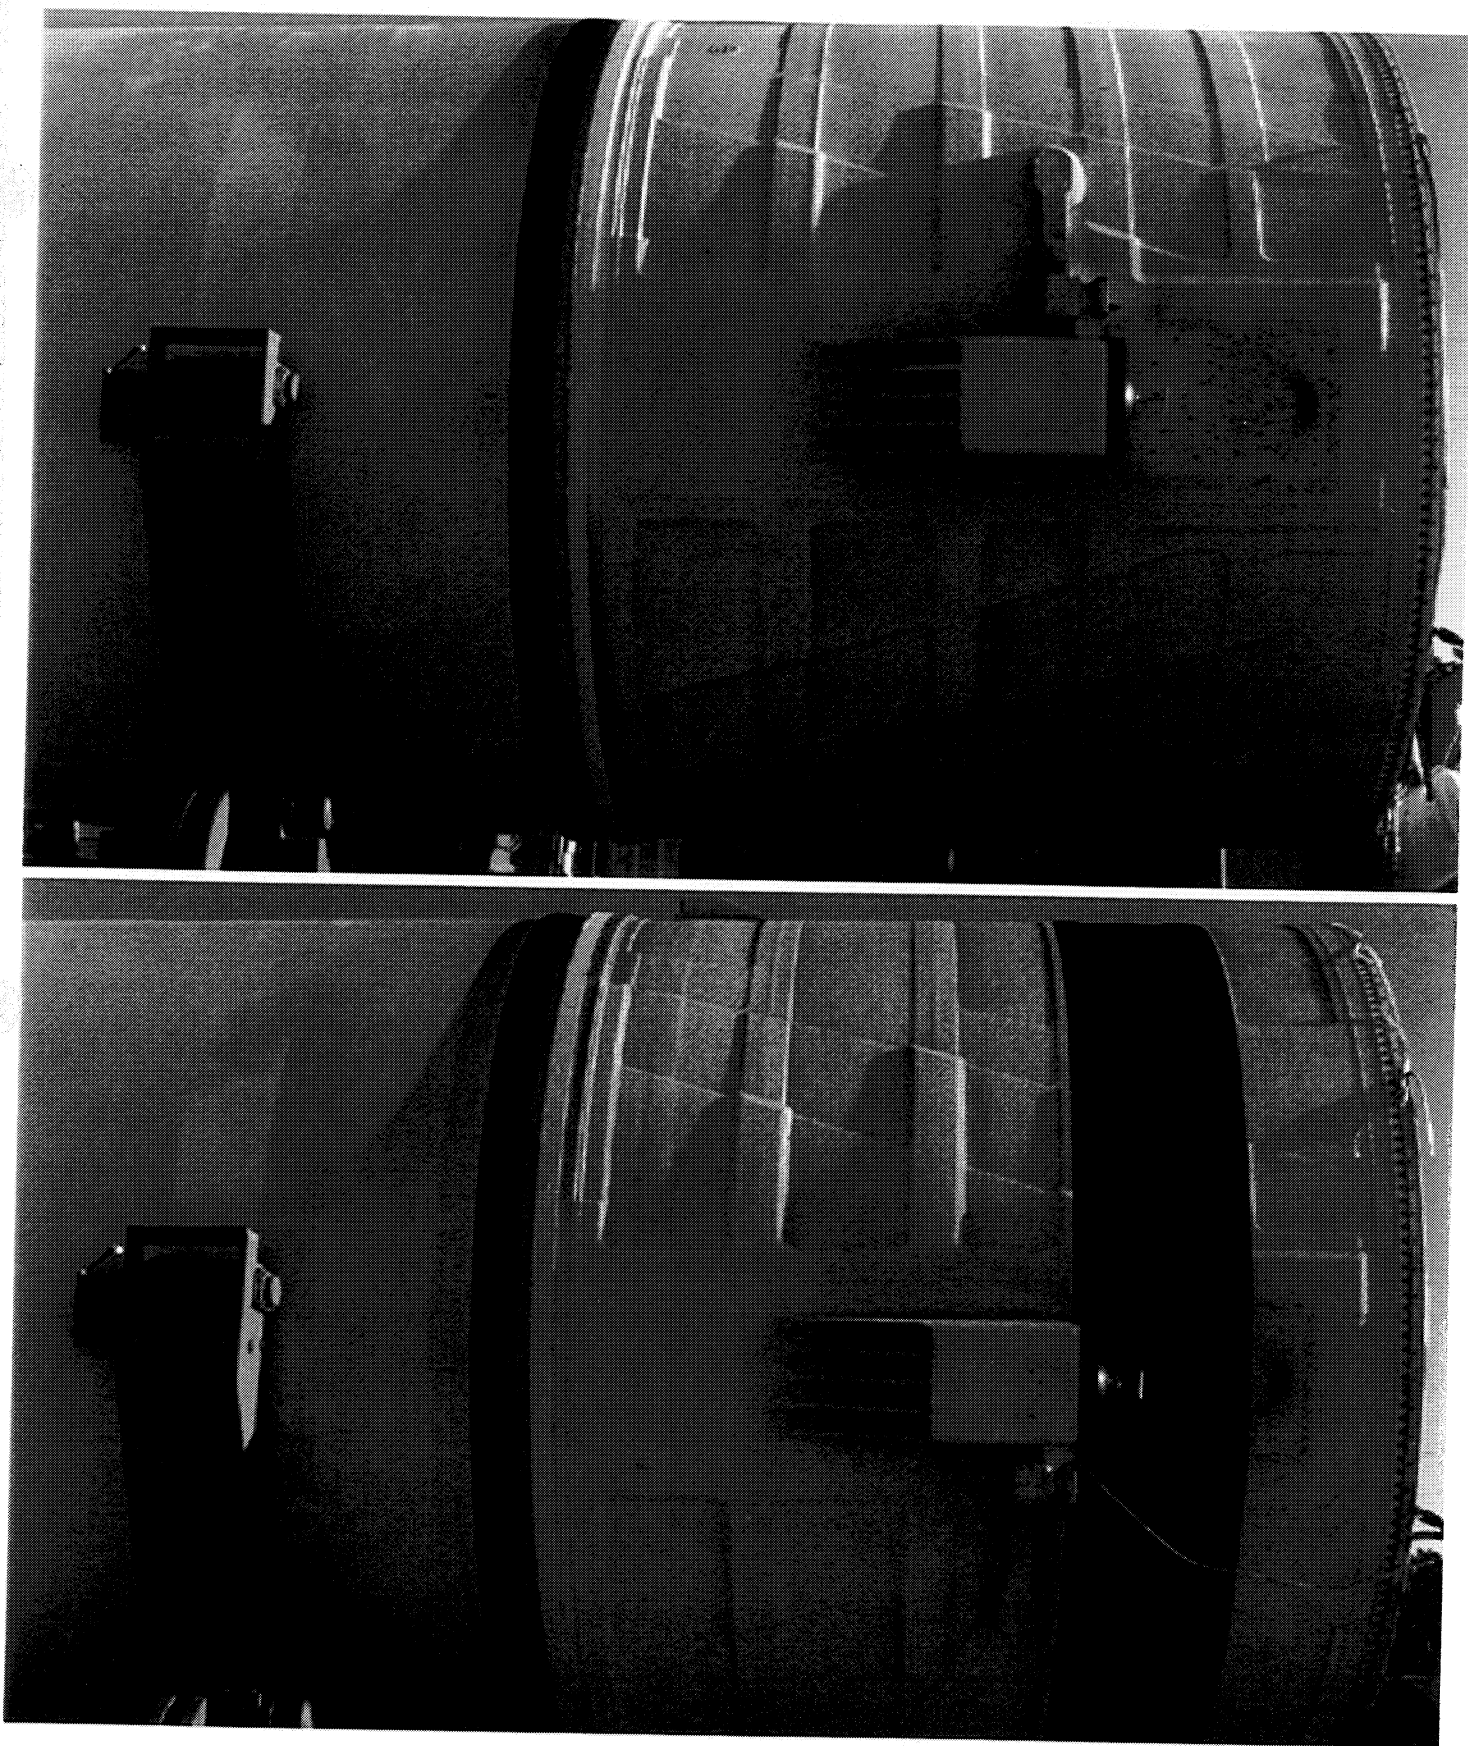
Photo 18: Forward Skirt Post Flight Condition

The forward skirts exhibited no debonds or missing TPS. RSS antennae covers/phenolic base plates were intact though one layer of phenolic had delaminated on both right and left SRB +Z sides. All primary frustum severance ring pins and retainer clips were intact.

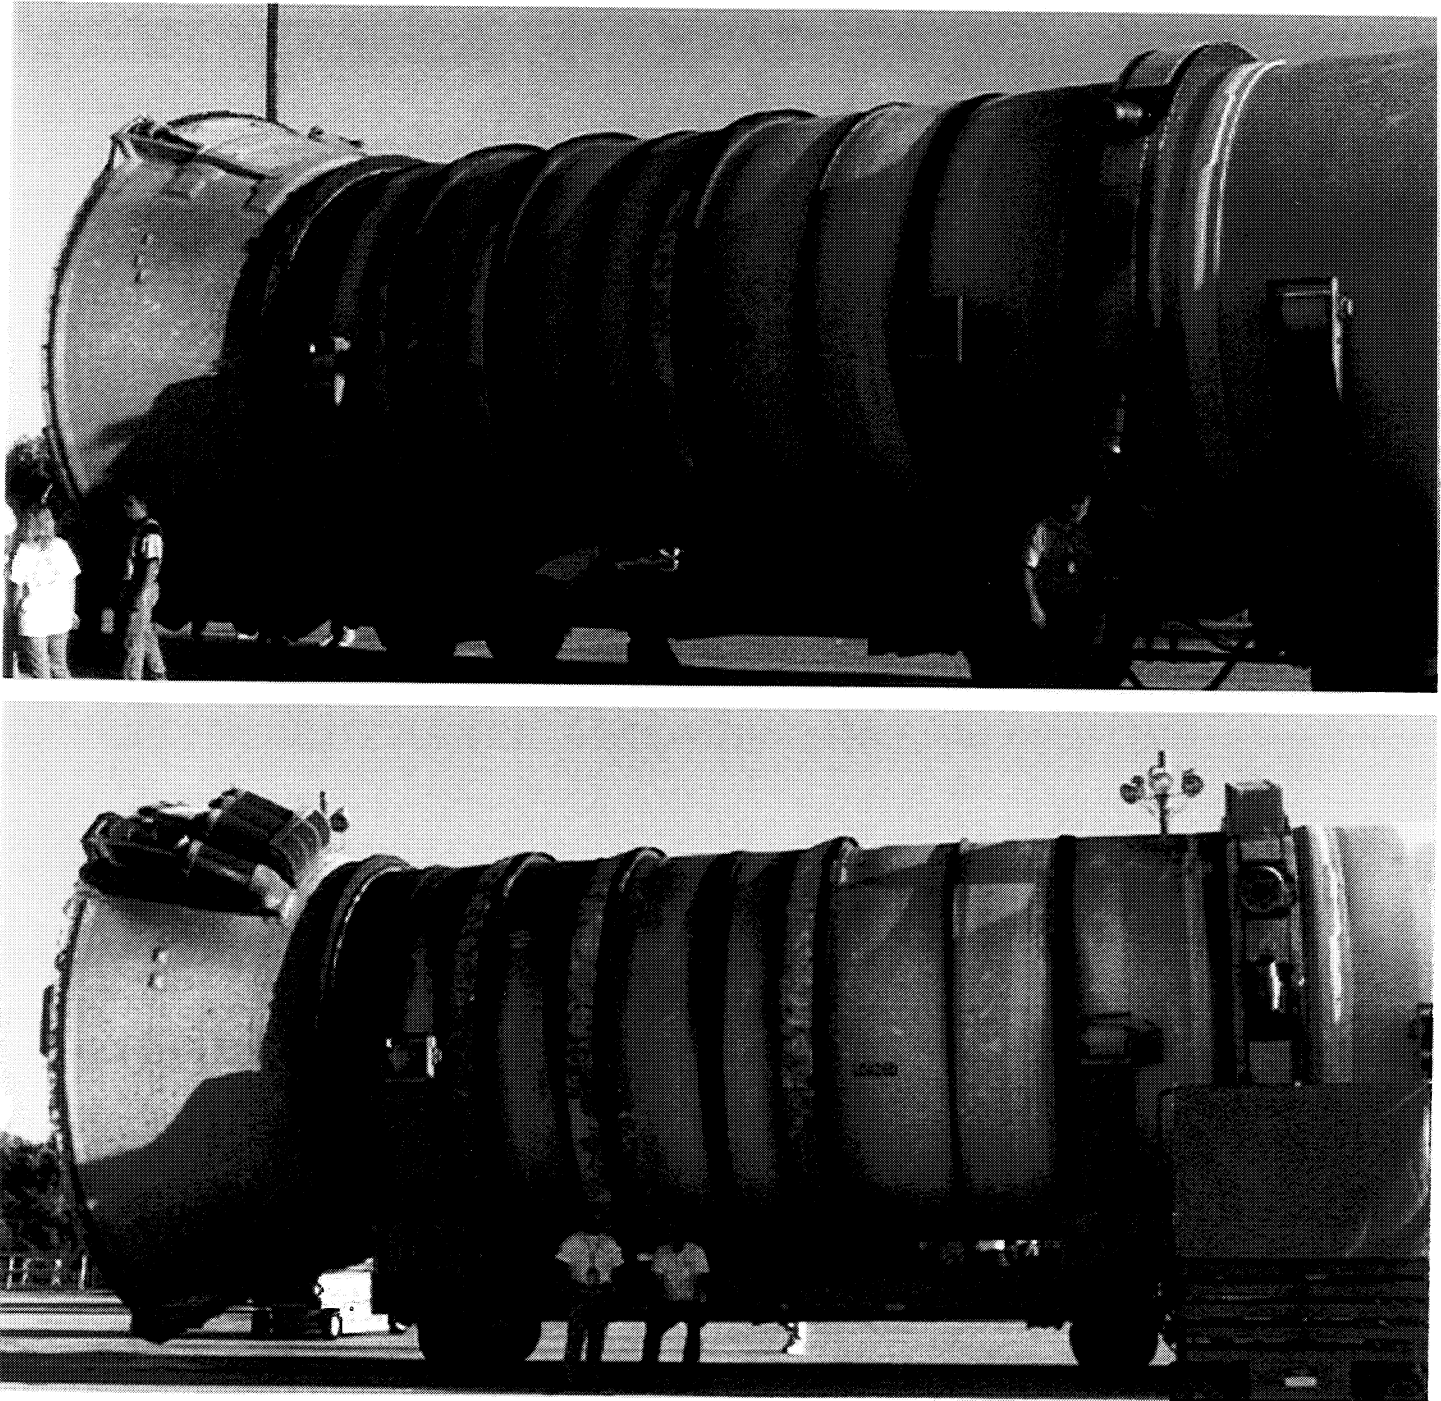
Photo 19: Aft Booster/Aft Skirt Post Flight Condition

Separation of the aft ET/SRB struts appeared normal. TPS on the external surface of both aft skirts was intact and in good condition.

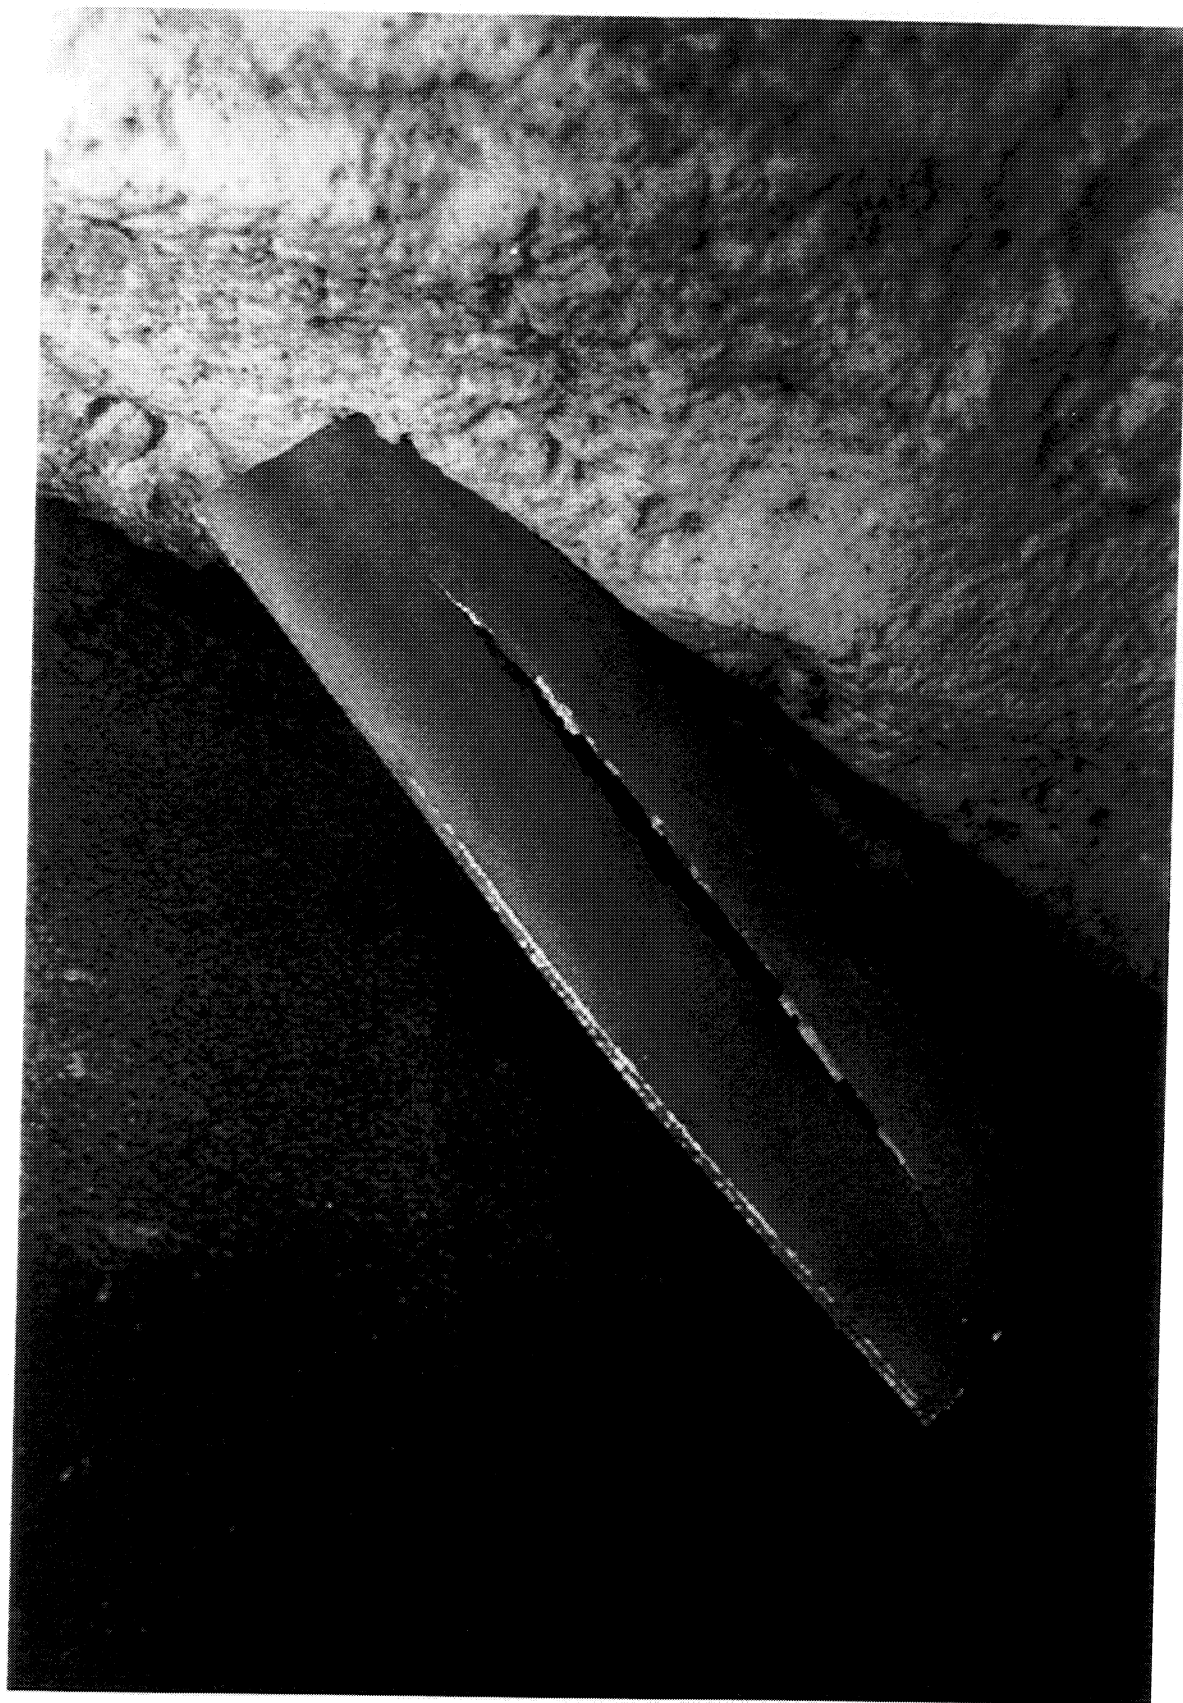
Photo 20: Nozzle Shim

An unusual finding consisted of a rectangular piece of metal, most likely a nozzle shim, 5-5/8 inches long by 2 inches wide by approximately 1/16 inch thick, imbedded in the right IEA aft surface protective foam close to the upper strut fairing. The shim probably came loose during nozzle severance.

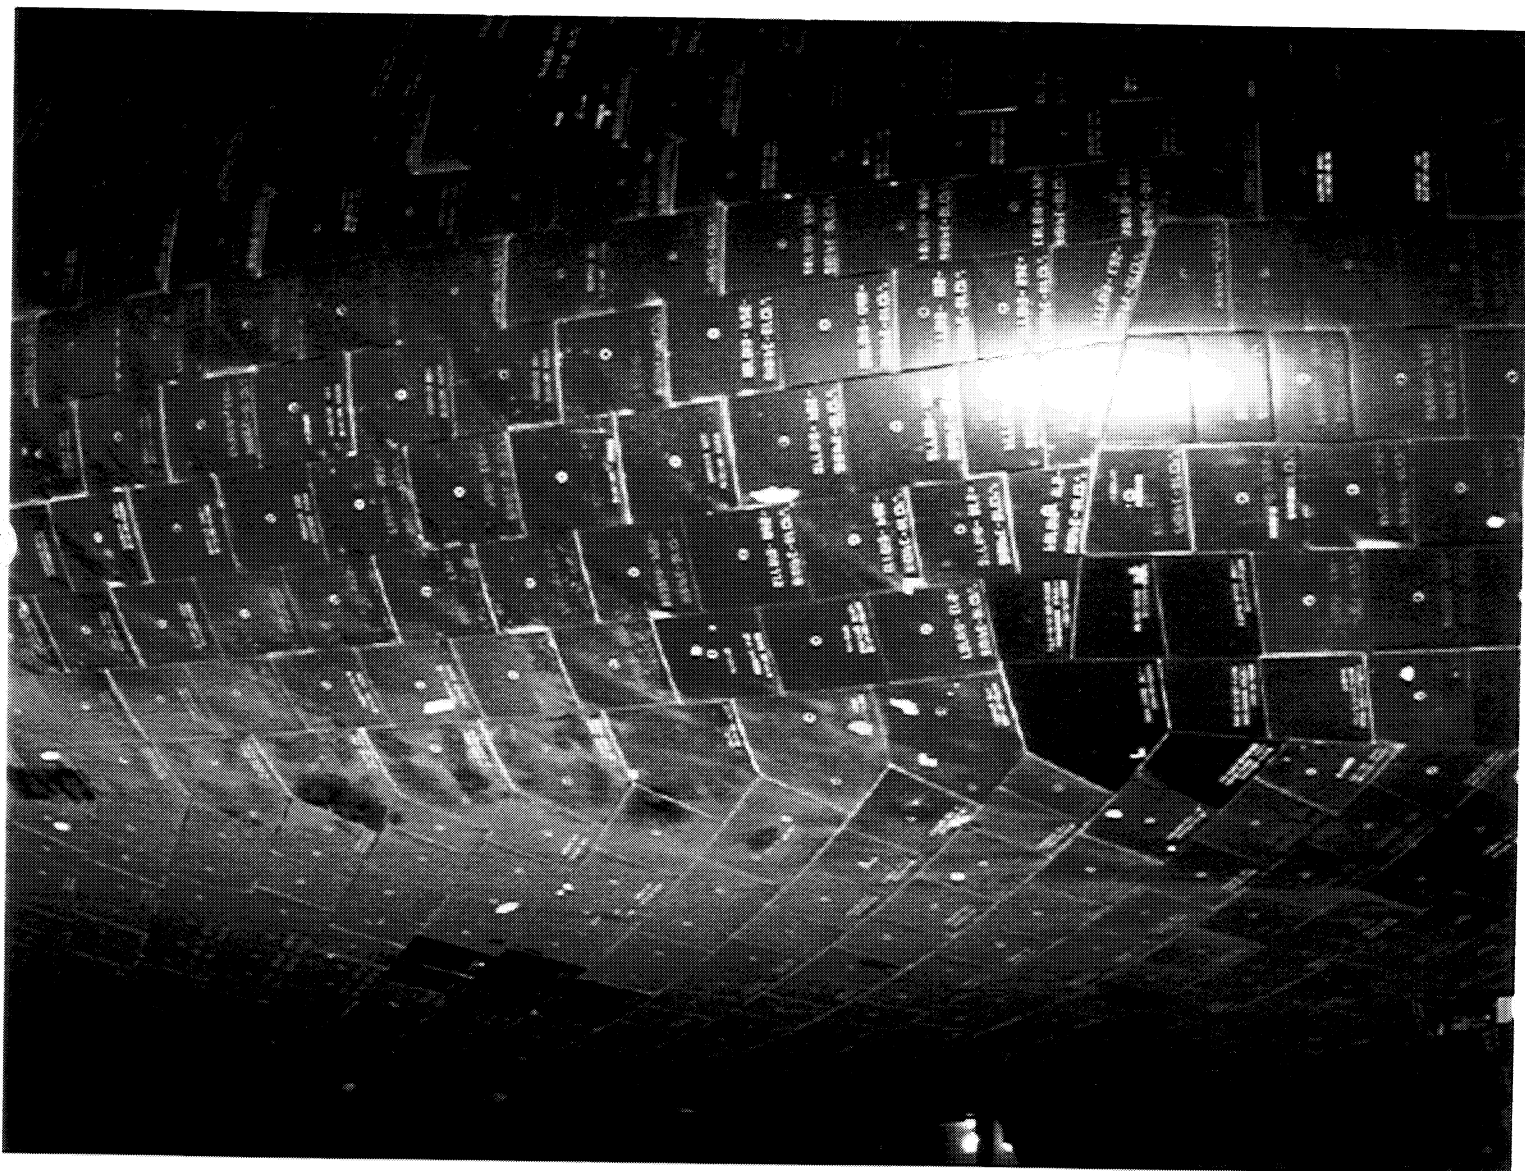
Photo 22: Lower Surface Tile Damage

The Orbiter lower surface sustained 80 total hits, of which 21 had a major dimension of 1-inch or larger. Most of this damage was concentrated between the nose gear and the main landing gear wheel wells on both left and right chines though the predominant number of damage sites occurred on the right side. (It should be noted there was no unusual or unexpected accumulations of ice in the ET LO2 feedline bellows and support brackets at the time of launch). The outboard damage sites on the chines followed a similar location/damage pattern documented on STS-86, -87, -89, -90, -91, and -95, though the pattern was not as symmetric as the previously noted flights. It should also be noted that this was the third flight of the new Super Light Weight Tank.

The Orbiter lower surface sustained 80 total hits, of which 21 had a major dimension of 1-inch or larger. Most of this damage was concentrated between the nose gear and the main landing gear wheel wells on both left and right chines though the predominant number of damage sites occurred on the right side. Virtually no damage occurred on the Orbiter centerline.

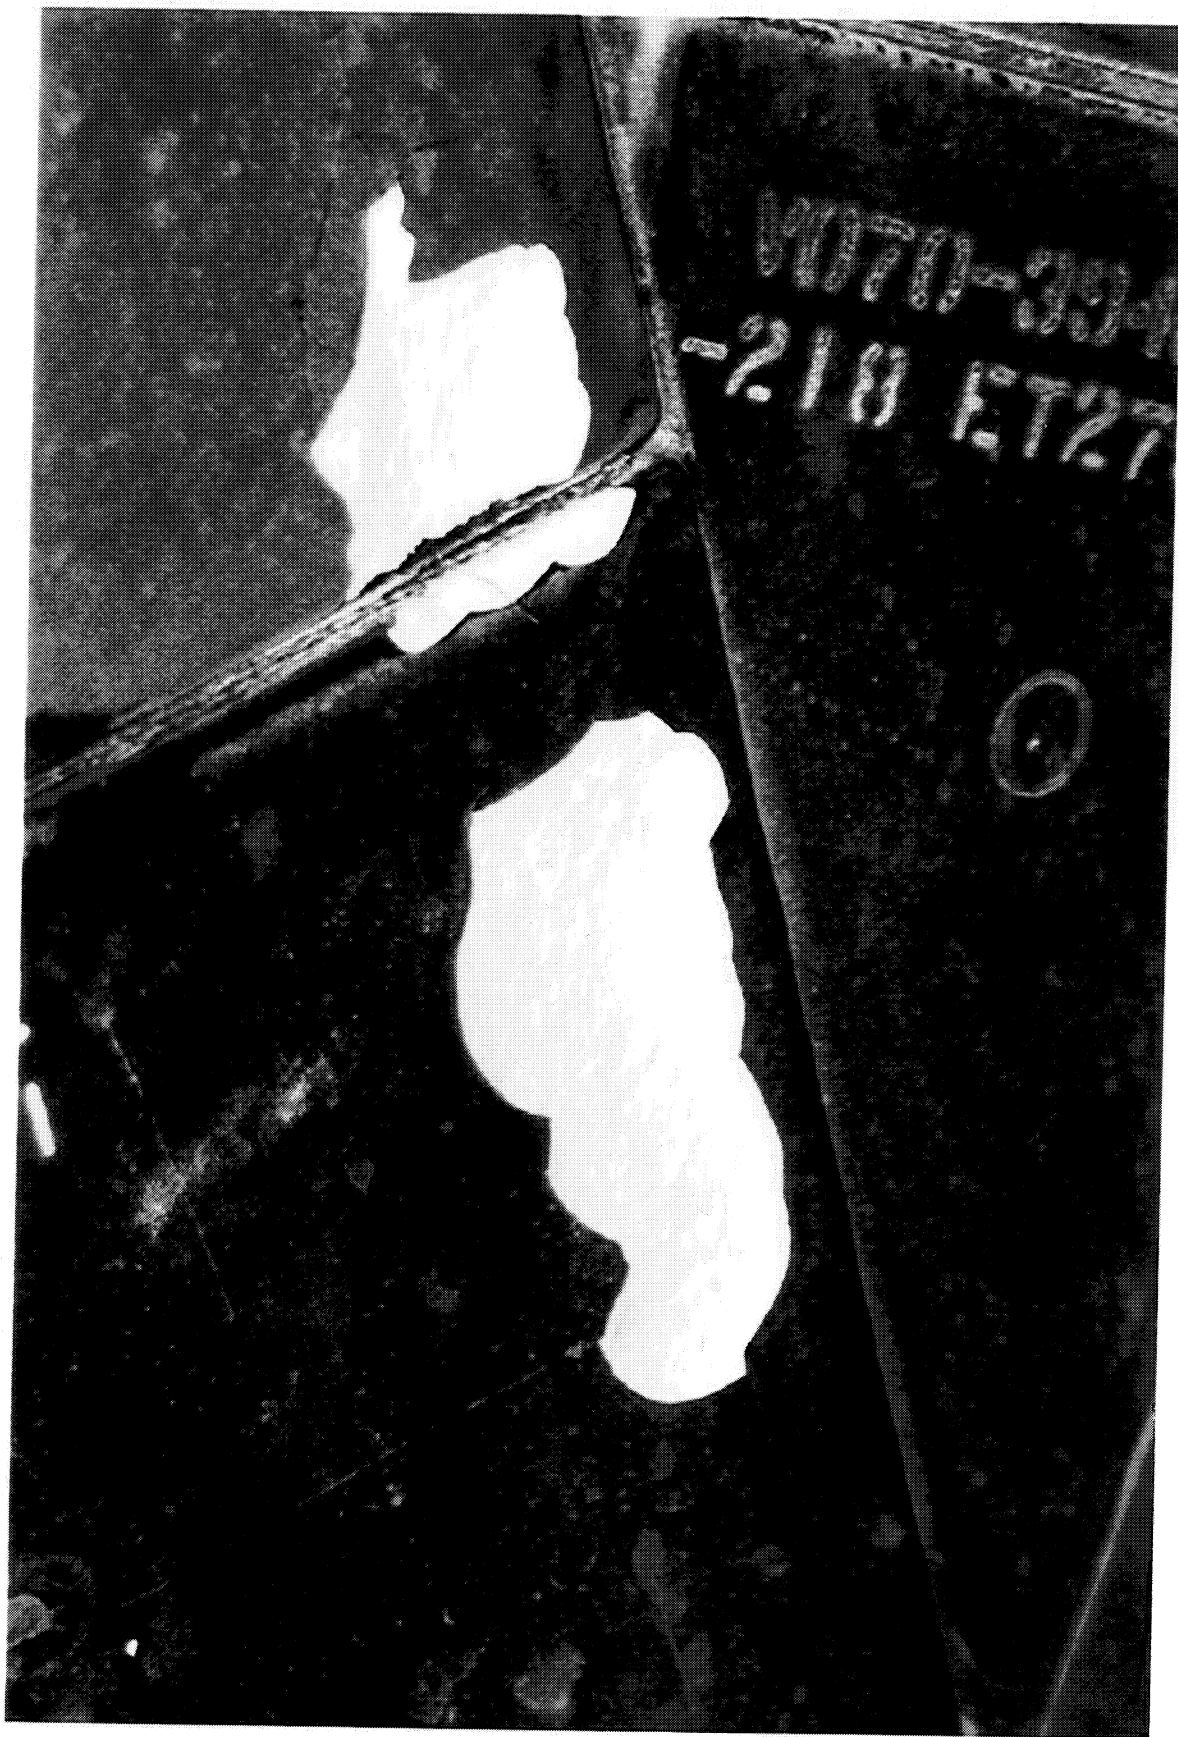
Photo 23: Lower Surface Tile Damage

No lower surface tiles were scrapped due to debris damage. The largest lower surface tile damage site, located on the right chine, measured 4.5-inches long by 1.125-inches wide by 0.125-inch deep. The deepest lower surface tile damage sites measured 0.5-inches and were located on the right chine.

The largest lower surface tile damage site, located on the right chine, measured 4.5-inches long by 1.125-inches wide by 0.125-inch deep. The deepest lower surface tile damage sites measured 0.5-inches and were located on the right chine.

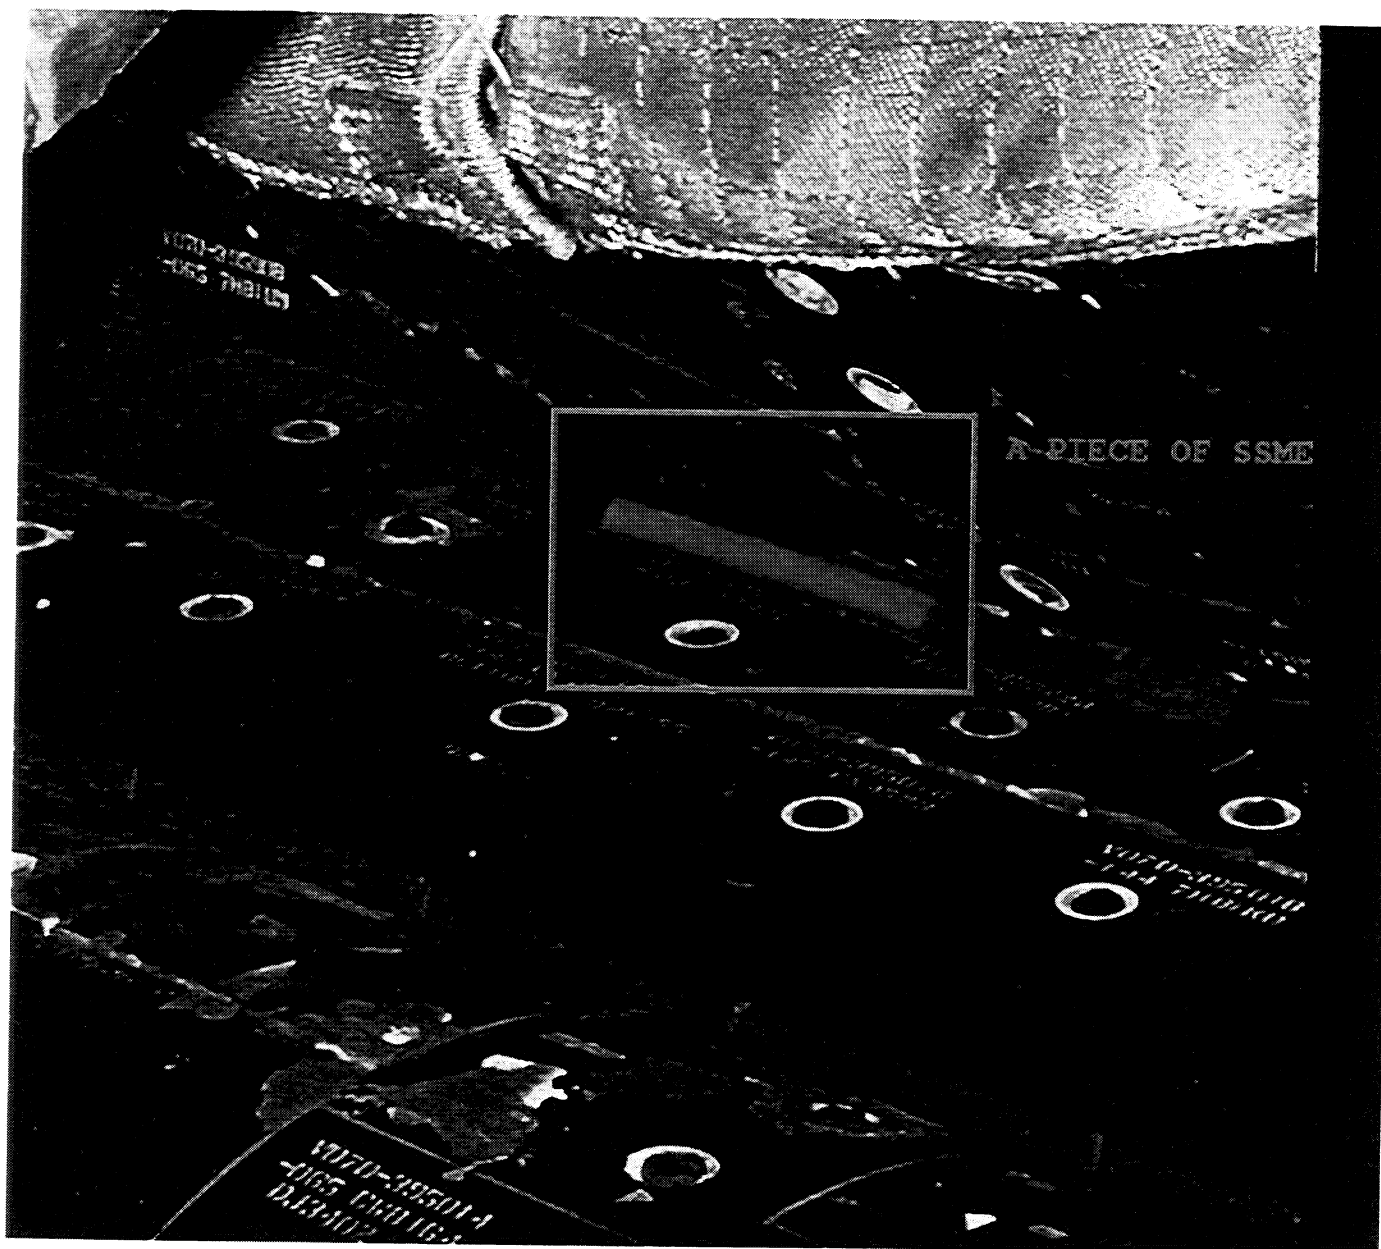
Photo 26: SSME Nozzle Ablator

Two pieces of SSME nozzle ablator, (6-inches and 4-inches long, respectively, by 3/4-inch wide by 3/8-inch thick), were found on Orbiter body flap stub tiles adjacent to the base heat shield beneath SSME #2. No impact damage to the tiles was detected. Inspection of the SSME #2 and #3 nozzles revealed approximately 60 percent of the ablator was missing.

Post flight assessment of the recovered ablator pieces and nozzle bonding surface reveal the material debonded after the heat of reentry, and therefore after peak heating of the SSME nozzles. Since it is highly unlikely the pieces of ablator could have remained on the body flap tiles during the aerodynamic turbulence and maneuvering of reentry, the material is believed to have shaken loose at main landing gear touchdown. Nevertheless, the ablator, with a density of about 92 pounds per cubic foot, is now considered to be a debris issue. IFA STS-88-I-01 was taken with a constraint to STS-93.

Pieces of SSME nozzle ablator were found on Orbiter body flap stub tiles adjacent to the base heat shield beneath SSME #2. No impact damage to the tiles was detected. Inspection of the SSME #2 and #3 nozzles revealed approximately 60 percent of the ablator was missing. The ablator was bonded to SSME #2 and #3 circumferentially from 45 degrees inboard to 90 degrees outboard on the -Z side of the nozzle to prevent the recurring problem of bluing.

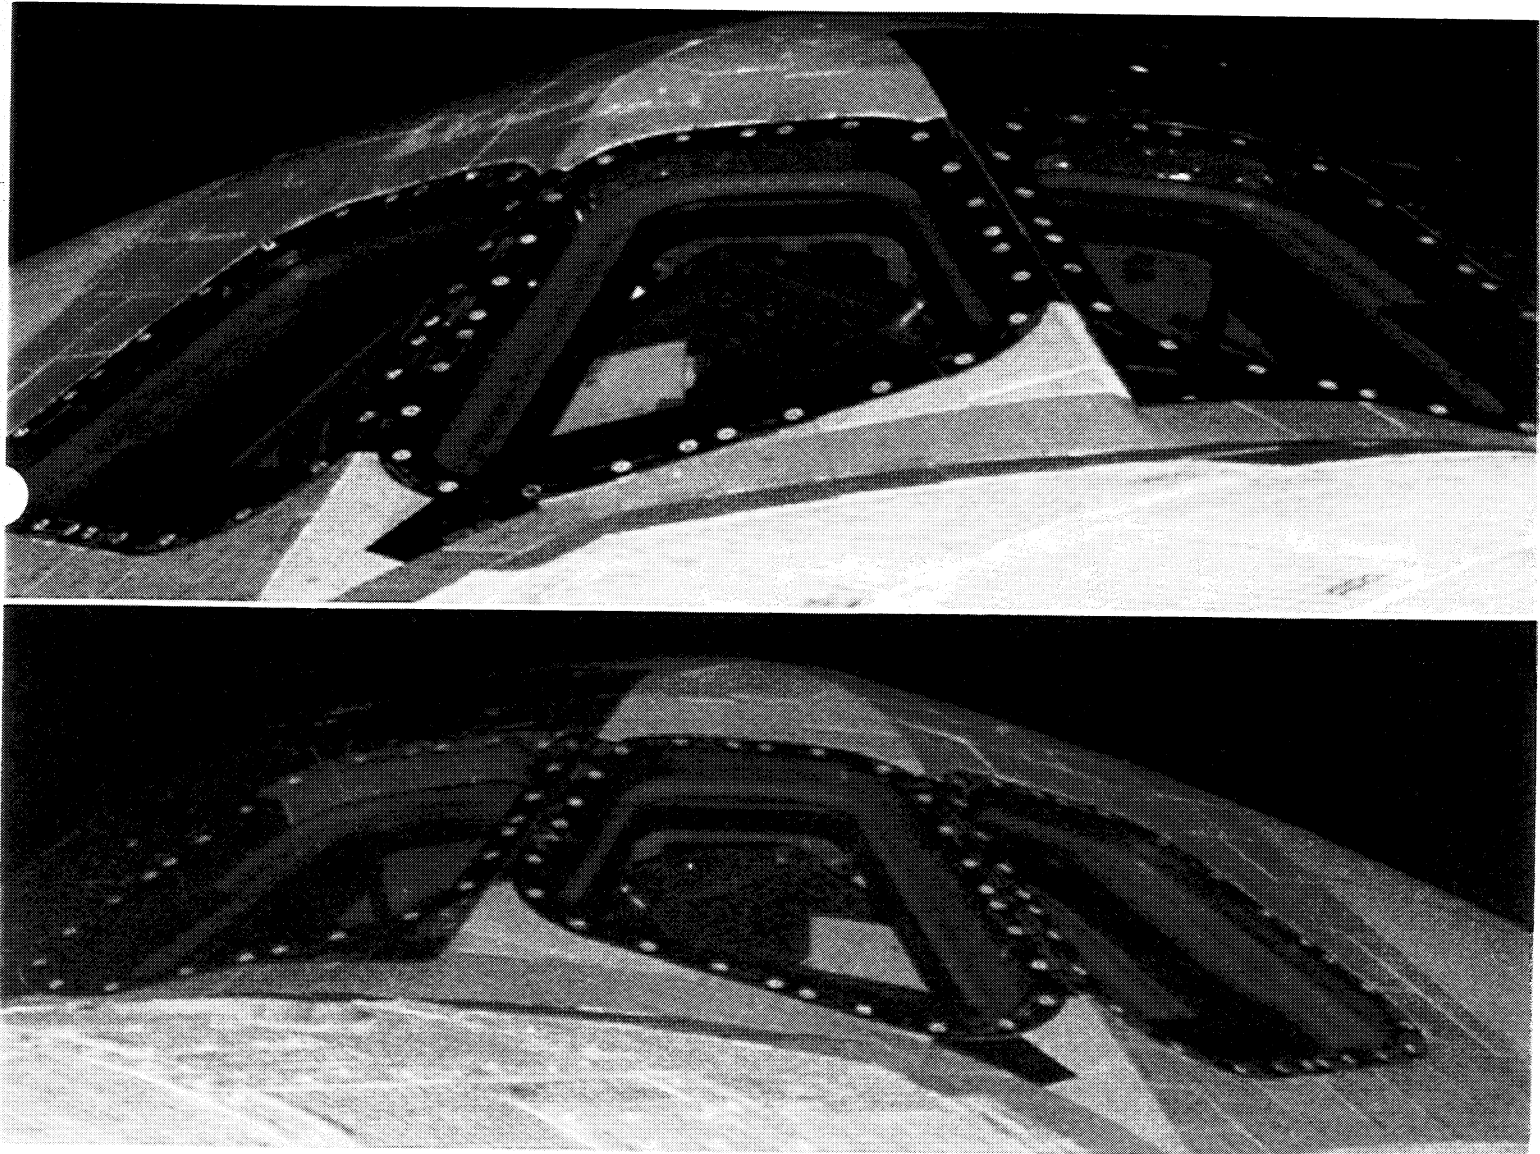
Photo 27: Windows

Hazing and streaking of forward-facing Orbiter windows was moderate. Damage sites on the window perimeter tiles were much less than usual in quantity and size. Some of the damage sites were attributed to old repair material falling out and were not included in this assessment.

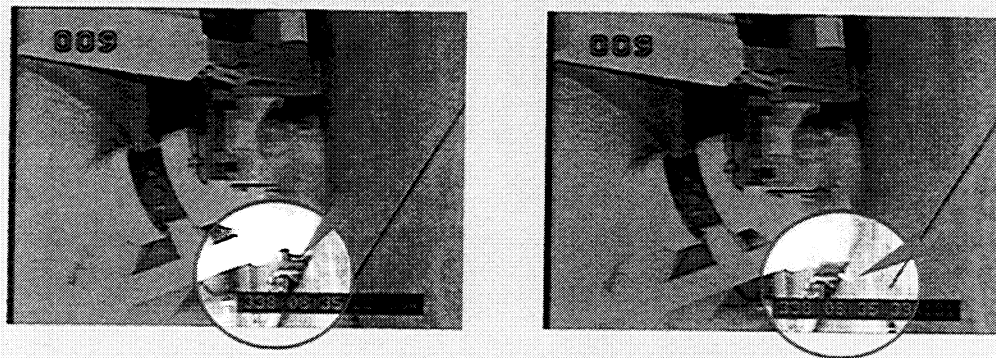
Figure 2.1 (A) Debris Near LH2 Umbilical

Camera OTV009
Light Colored Flexible Debris (Unidentified)
From LH2 Umbilical Area

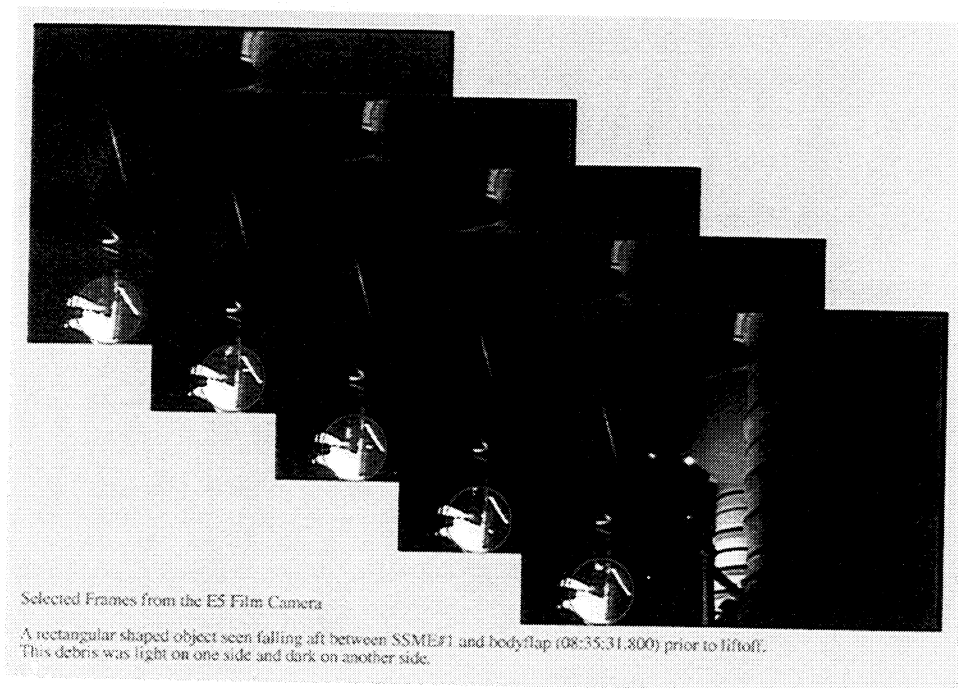
Figure 2.1 (B) Rectangular Shaped Debris between SSME # 1 and Body Flap

A thin, white-colored rectangular shaped piece of debris was seen between the body flap and SSME #3 prior to liftoff (08:35:31.800 UTC). The origin and identification of this debris was not determined. (Camera E5)

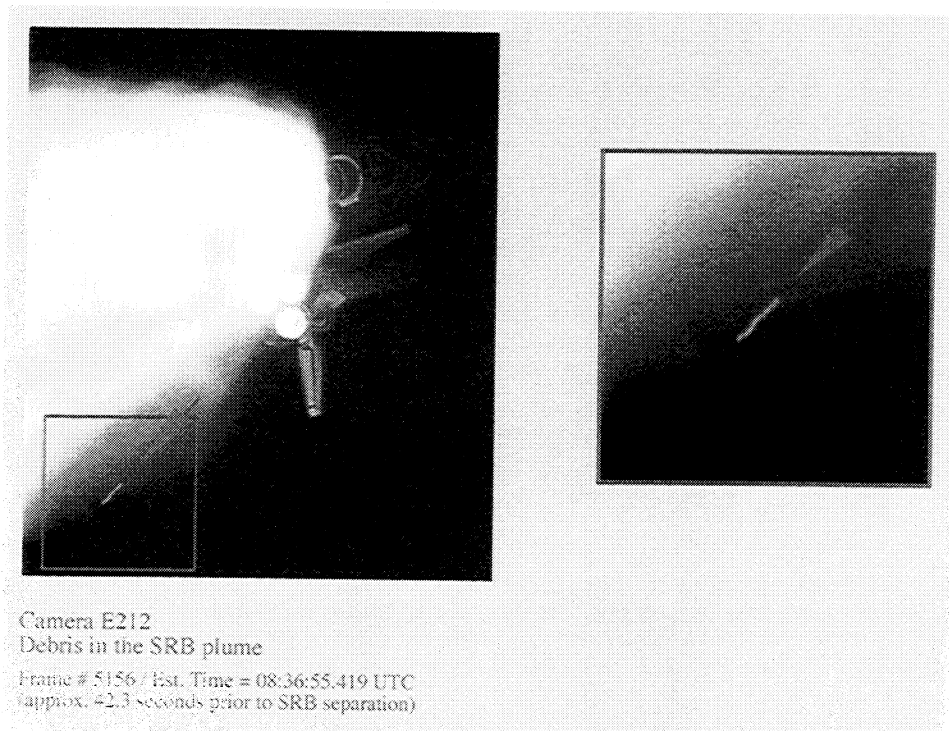
Figure 2.2 Linear Shaped Debris Near SRB Exhaust Plume

Approximately nine pieces of debris (probably SRB aft skirt instafoam) were seen near the SRB exhaust plume during ascent (08:36:45.59, 08:36:50.67, 08:36:52.17, 08:36:52.87, 08:36:53.24 UTC). Several of these debris appeared linear shaped, possibly due to image motion smear. On camera E212, a single large appearing piece of debris was seen falling from near the aft end of the LSRB. (Cameras KTV4A, KTV5A, ET212, E52, E54, E207, E212, E222, E223, E224)

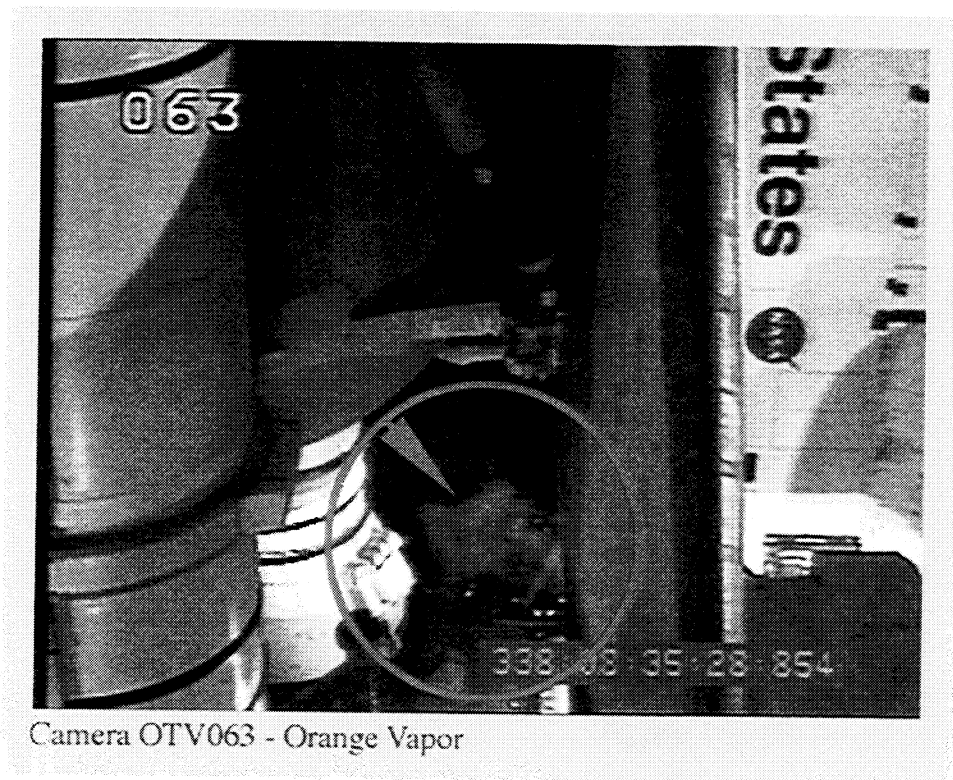
Figure 2.3.1 (A) Orange Vapor between RSRB and Body flap

Orange vapor, probably free burning hydrogen, was clearly visible moving forward along the north-side of the bodyflap during SSME ignition.
